Project# 04-0120F4

Metallurgical Analysis of Bay Bridge Broken Anchor Rods S1-G1 & S2-A6

Metallurgical testing and fracture analysis was performed on two broken anchor rods that were removed from shear keys S1 and S2. The results indicate that hydrogen embrittlement was the cause of the recent anchor rod failures. Generally, the critical factor to consider when fasteners fail due to hydrogen embrittlement (HE) is the susceptibility of the material to hydrogen assisted cracking. Strength has a first order effect on susceptibility. When the specified tensile strength exceeds 180 ksi (i.e., hardness above 39 HRC), HE susceptibility increases very rapidly. Other variables such as microstructure, fracture toughness and notch sensitivity of the steel have a second order effect that can be significant. Given that (i) critical fasteners are often tensioned to maximize their clamping capacity, and (ii) hydrogen concentrations may be influenced by process conditions and environmental service conditions such as corrosion generated hydrogen, the most effective manner to prevent HE related failures of fasteners is to limit the susceptibility of the material. Conversely, in the rare cases wher

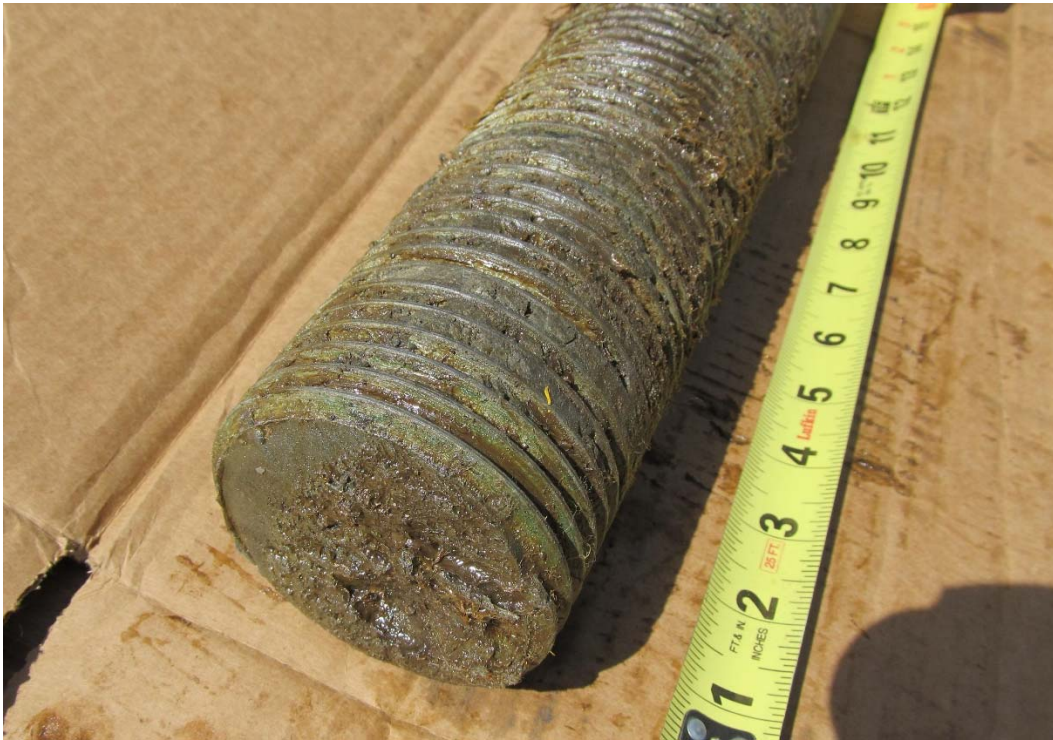
The overall appearance of both rod fractures was brittle (i.e., there was no thread elongation/stretching to suggest plastic deformation/yielding occurred prior to fracture). Photos 2-8 show the observed fracture features. There was evidence indicating that hydrogen assisted cracks were present in both rods prior to failure. The cracks initiated and extended from the thread root up to a depth of 0.6 inches in Rod S1-G1, and 0.4 inches in Rod S2-A6 (see Photos 4 and 8). The presence and appearance of the cracks, and the delayed nature of the fractures point to time dependence of the failure mechanism. Cracks developed and grew in both rods, which progressively exceeded their capacity with time, and resulted in final failure by fast fracture.

Photo 2) Broken anchor rod S1-G1.

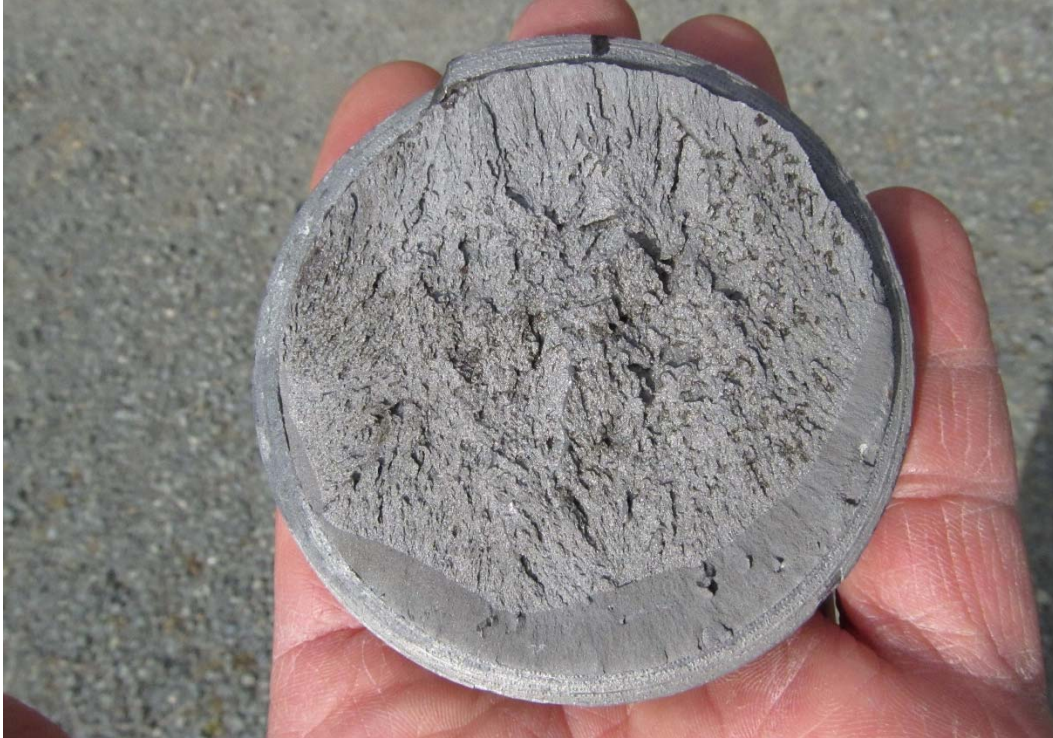
Photo 7) Fracture surface of Rod S2-A6 after cleaning.

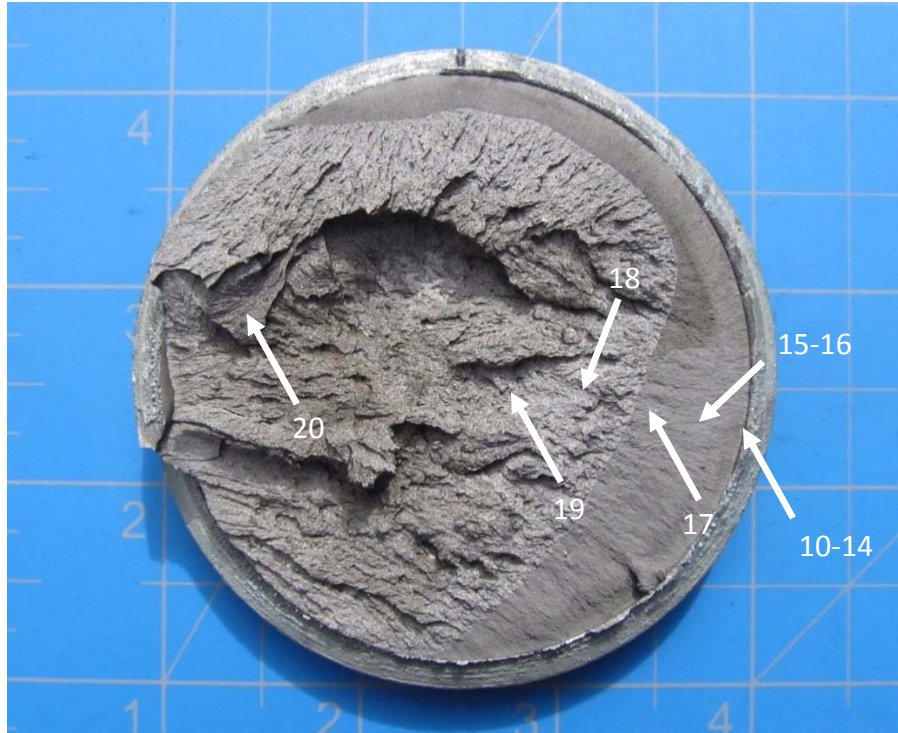
Photo 9) Fractured rod S1-G1 showing the locations of SEM photos 10-20.

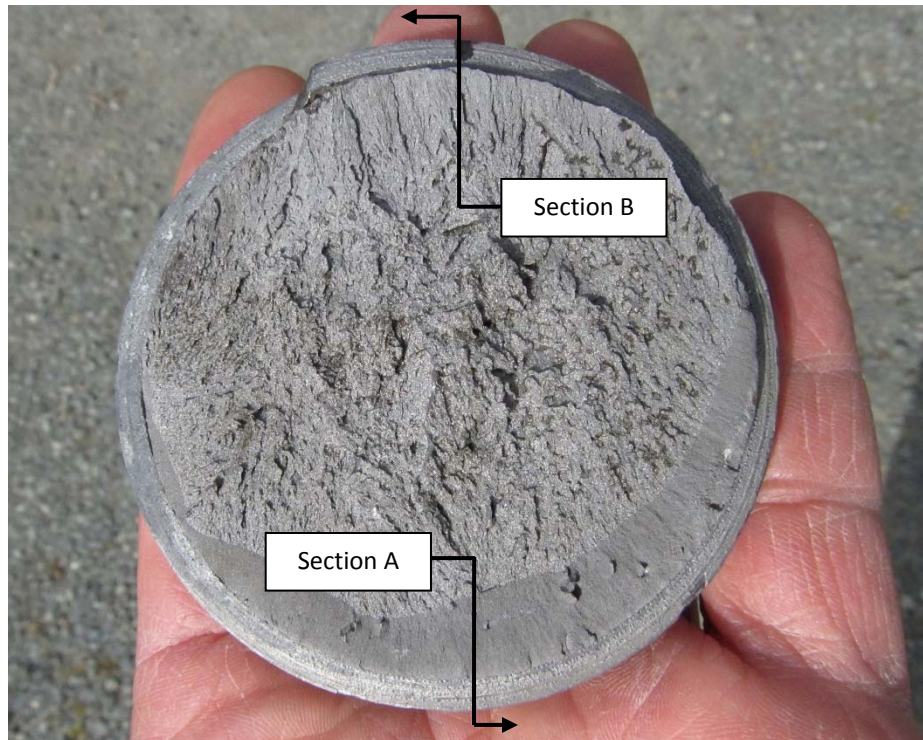
Cross-sections were cut from both rods and metallurgically prepared (i.e., mounted/potted, polished and etched). The location of the cross-sections is shown in Photos 21-22. The observed microstructure was generally tempered martensite, which is the normal structure associated with quenched and tempered AISI 4140 steel. However, many areas especially toward the center of the rod, showed evidence of incomplete martensitic transformation. The regions of incomplete transformation, as characterized by the observed presence of ferrite and pearlite, appeared to alternate in banded layers between regions of fully transformed martensitic structure. The banded nature of the microstructure is an indication that the material is not homogeneous. See Photos 23-26. Additionally, there was a relatively high amount of non-metallic stringer inclusions present in the microstructure. See Photos 27 and 28.

Photo 21) Fractured rod S2-A6 showing the location of cross-sections for microstructural examination and microhardness tests.

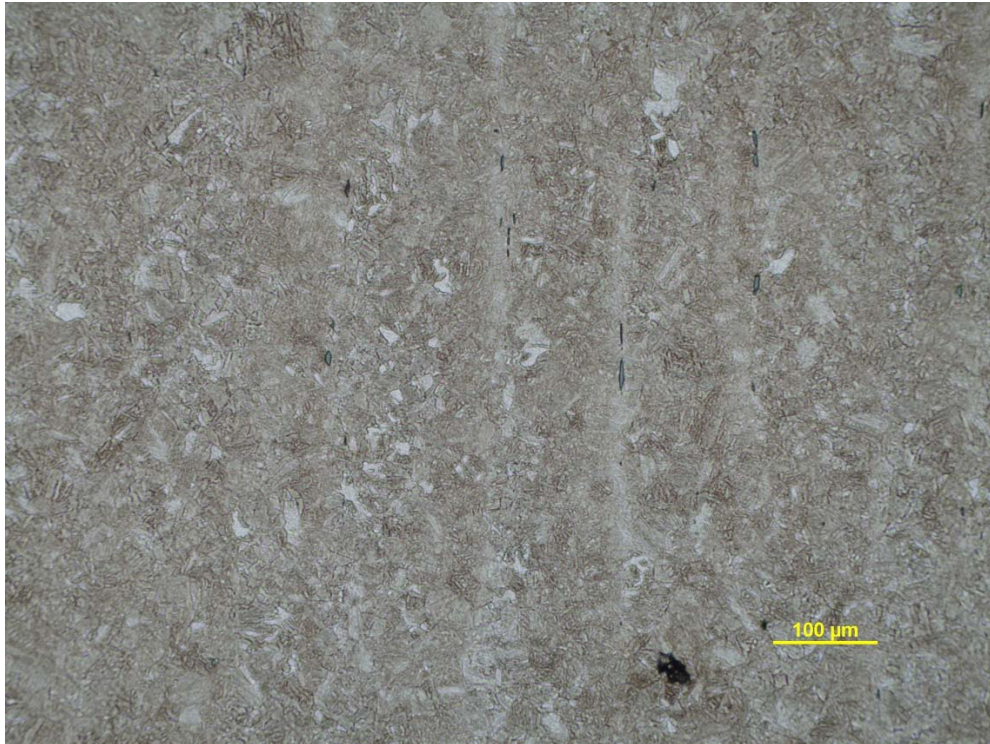
Photo 25) Another example of microstructure observed in S2-A6. Note vertical banding (alternating light-dark streaks) in grain direction. (Etchant: 2% Nital)
